Measuring Eelgrass Damage in Richardson Bay

Habitat Monitoring – December 2022

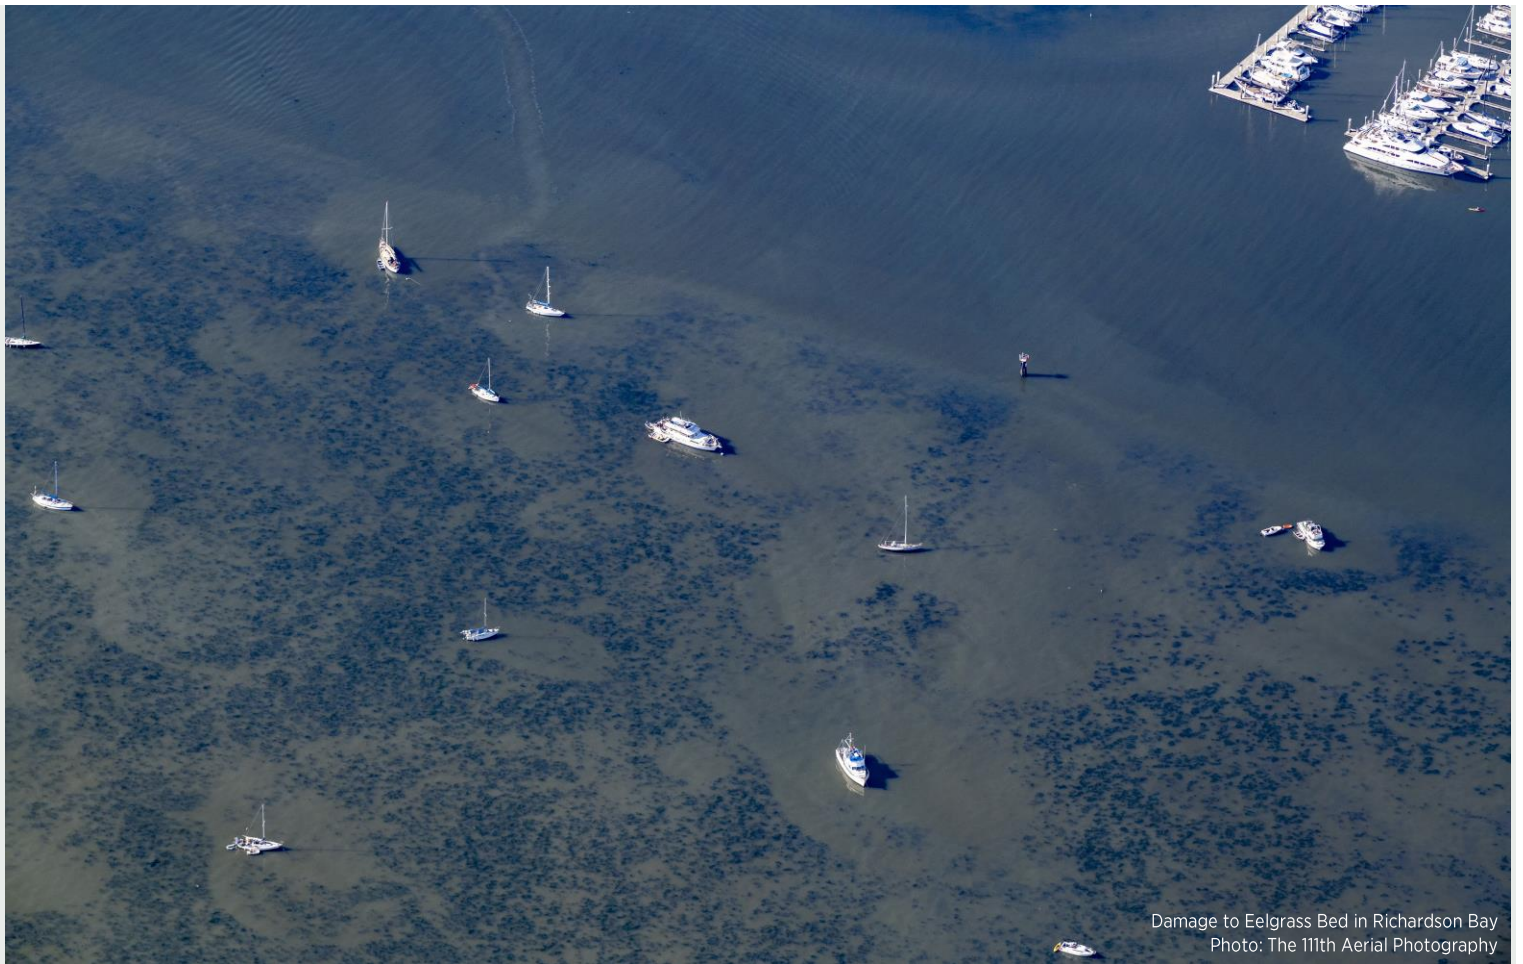
Damage to Eelgrass Bed in Richardson Bay
Photo: The 111th Aerial Photography

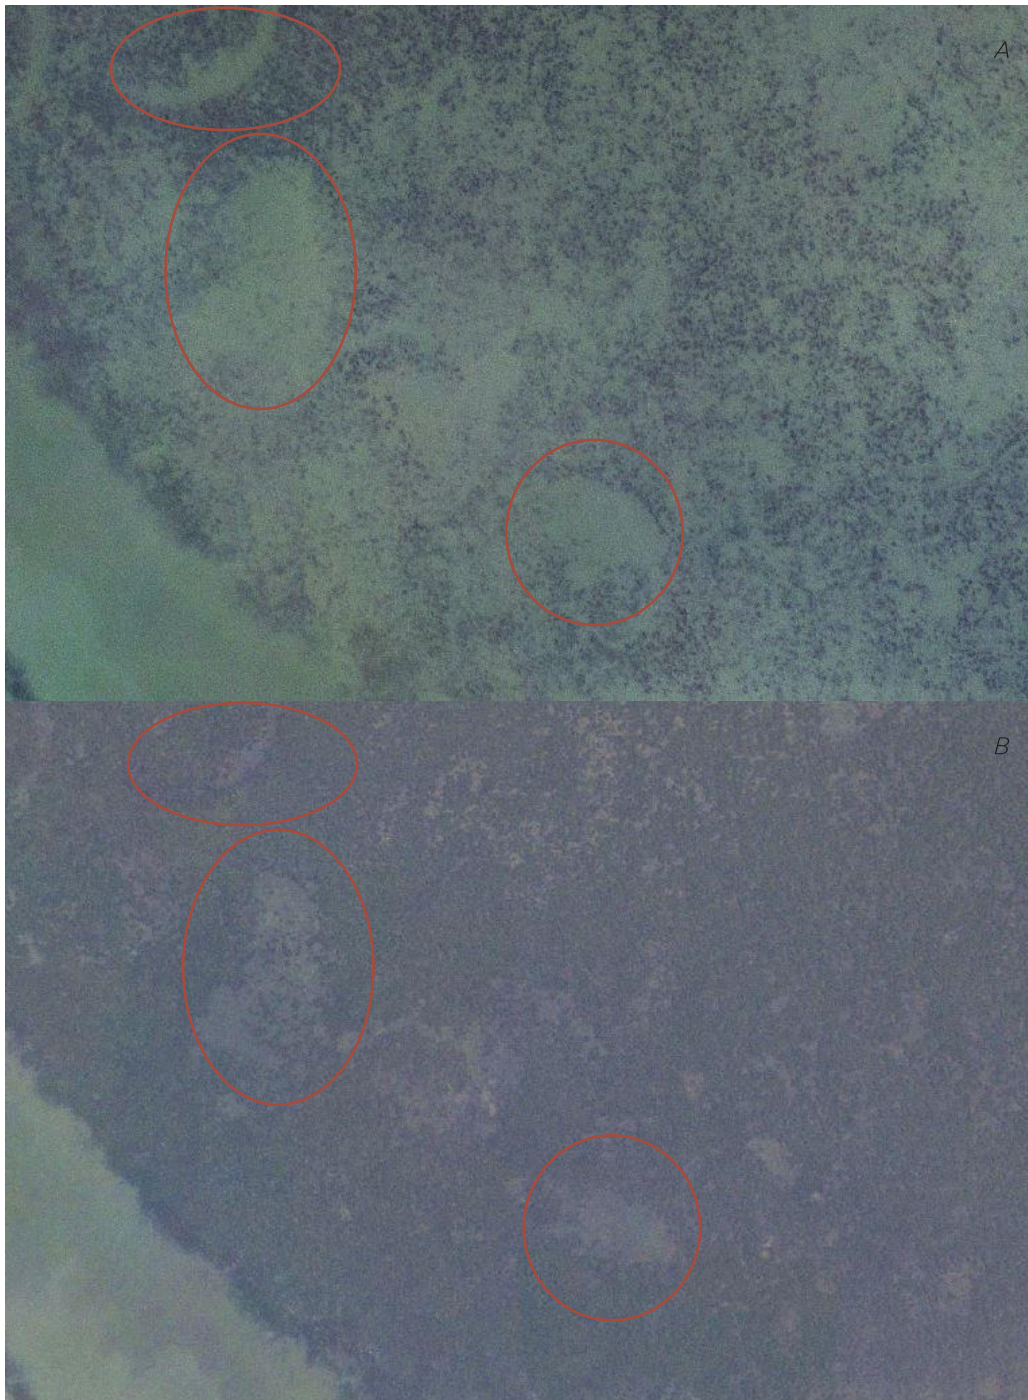
Figure 5. Examples of anchor scars in Richardson Bay eelgrass bed from 2021 (A) that have begun to recover in 2022 (B).

By comparing the imagery across the three separate study years, it is clear there has been a handful of locations where the removal of an anchored-out vessel resulted in the recolonization of eelgrass in a previous scar. One clear example of eelgrass growth in a previous scar can be found in Figure 5. Unsurprisingly, there are a number of damaged areas that were clear of boats in the 2021 imagery that have still not recovered by the time the 2022 aerial imagery was collected suggesting that the grass will take longer than one year to recover in some instances. (Figure 6)

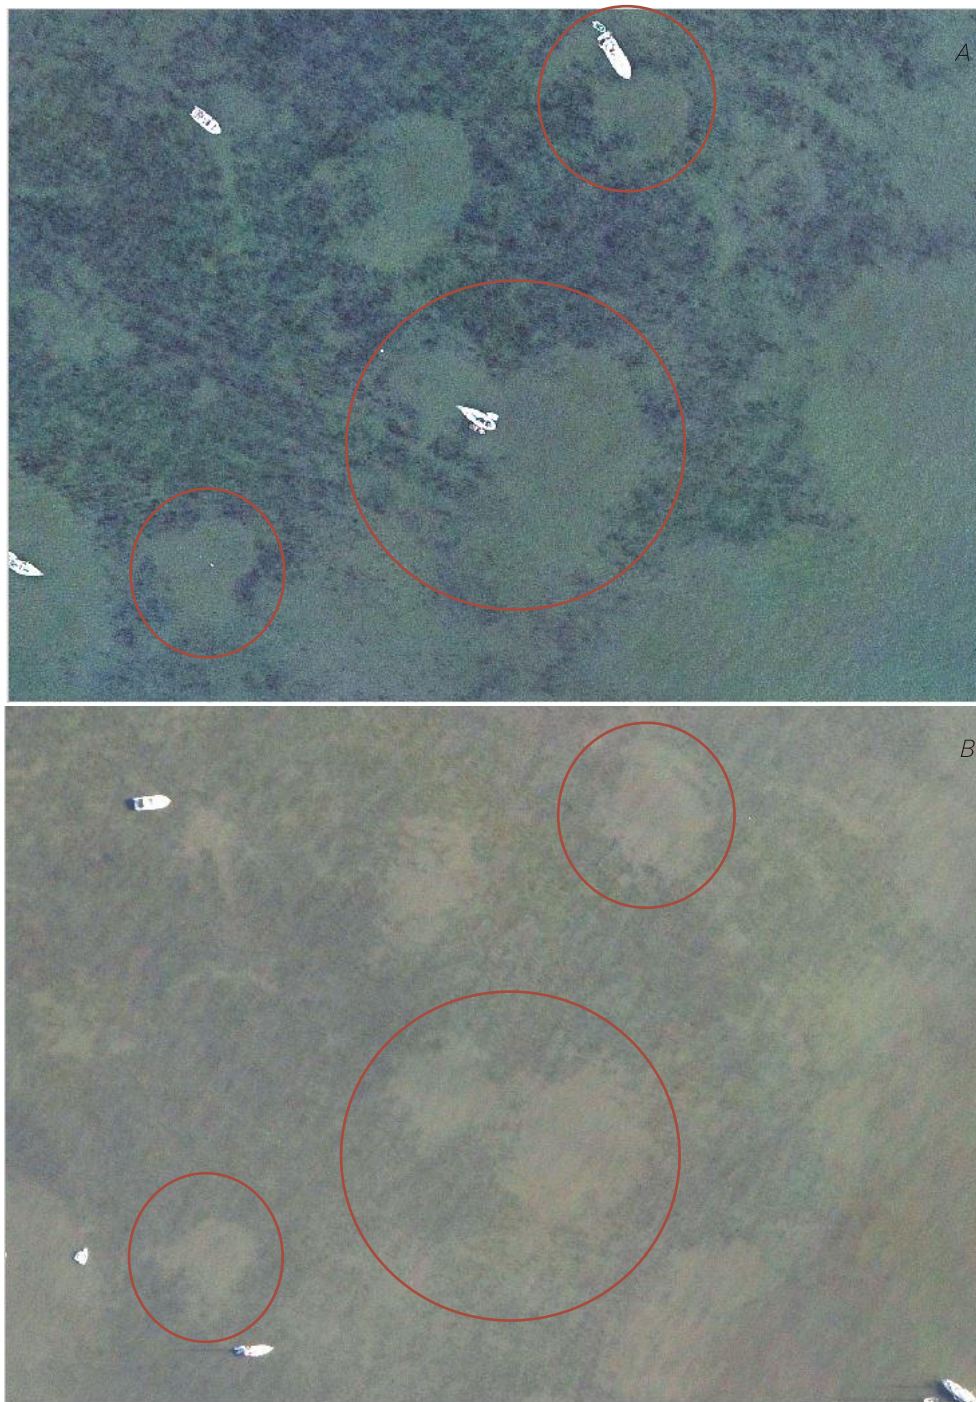
Figure 6. Examples of anchor scars in Richardson Bay eelgrass bed from 2021 (A) that have not recovered well in 2022 (B).
