Merkel & Associates, Inc.

Re: 2022 Richardson Bay Eelgrass Inventory and 2019-2022 Change Analysis

This memorandum serves to transmit information regarding the 2022 Richardson Bay eelgrass (*Zostera marina*) survey results and the results of the 2019-2022 eelgrass change analysis.

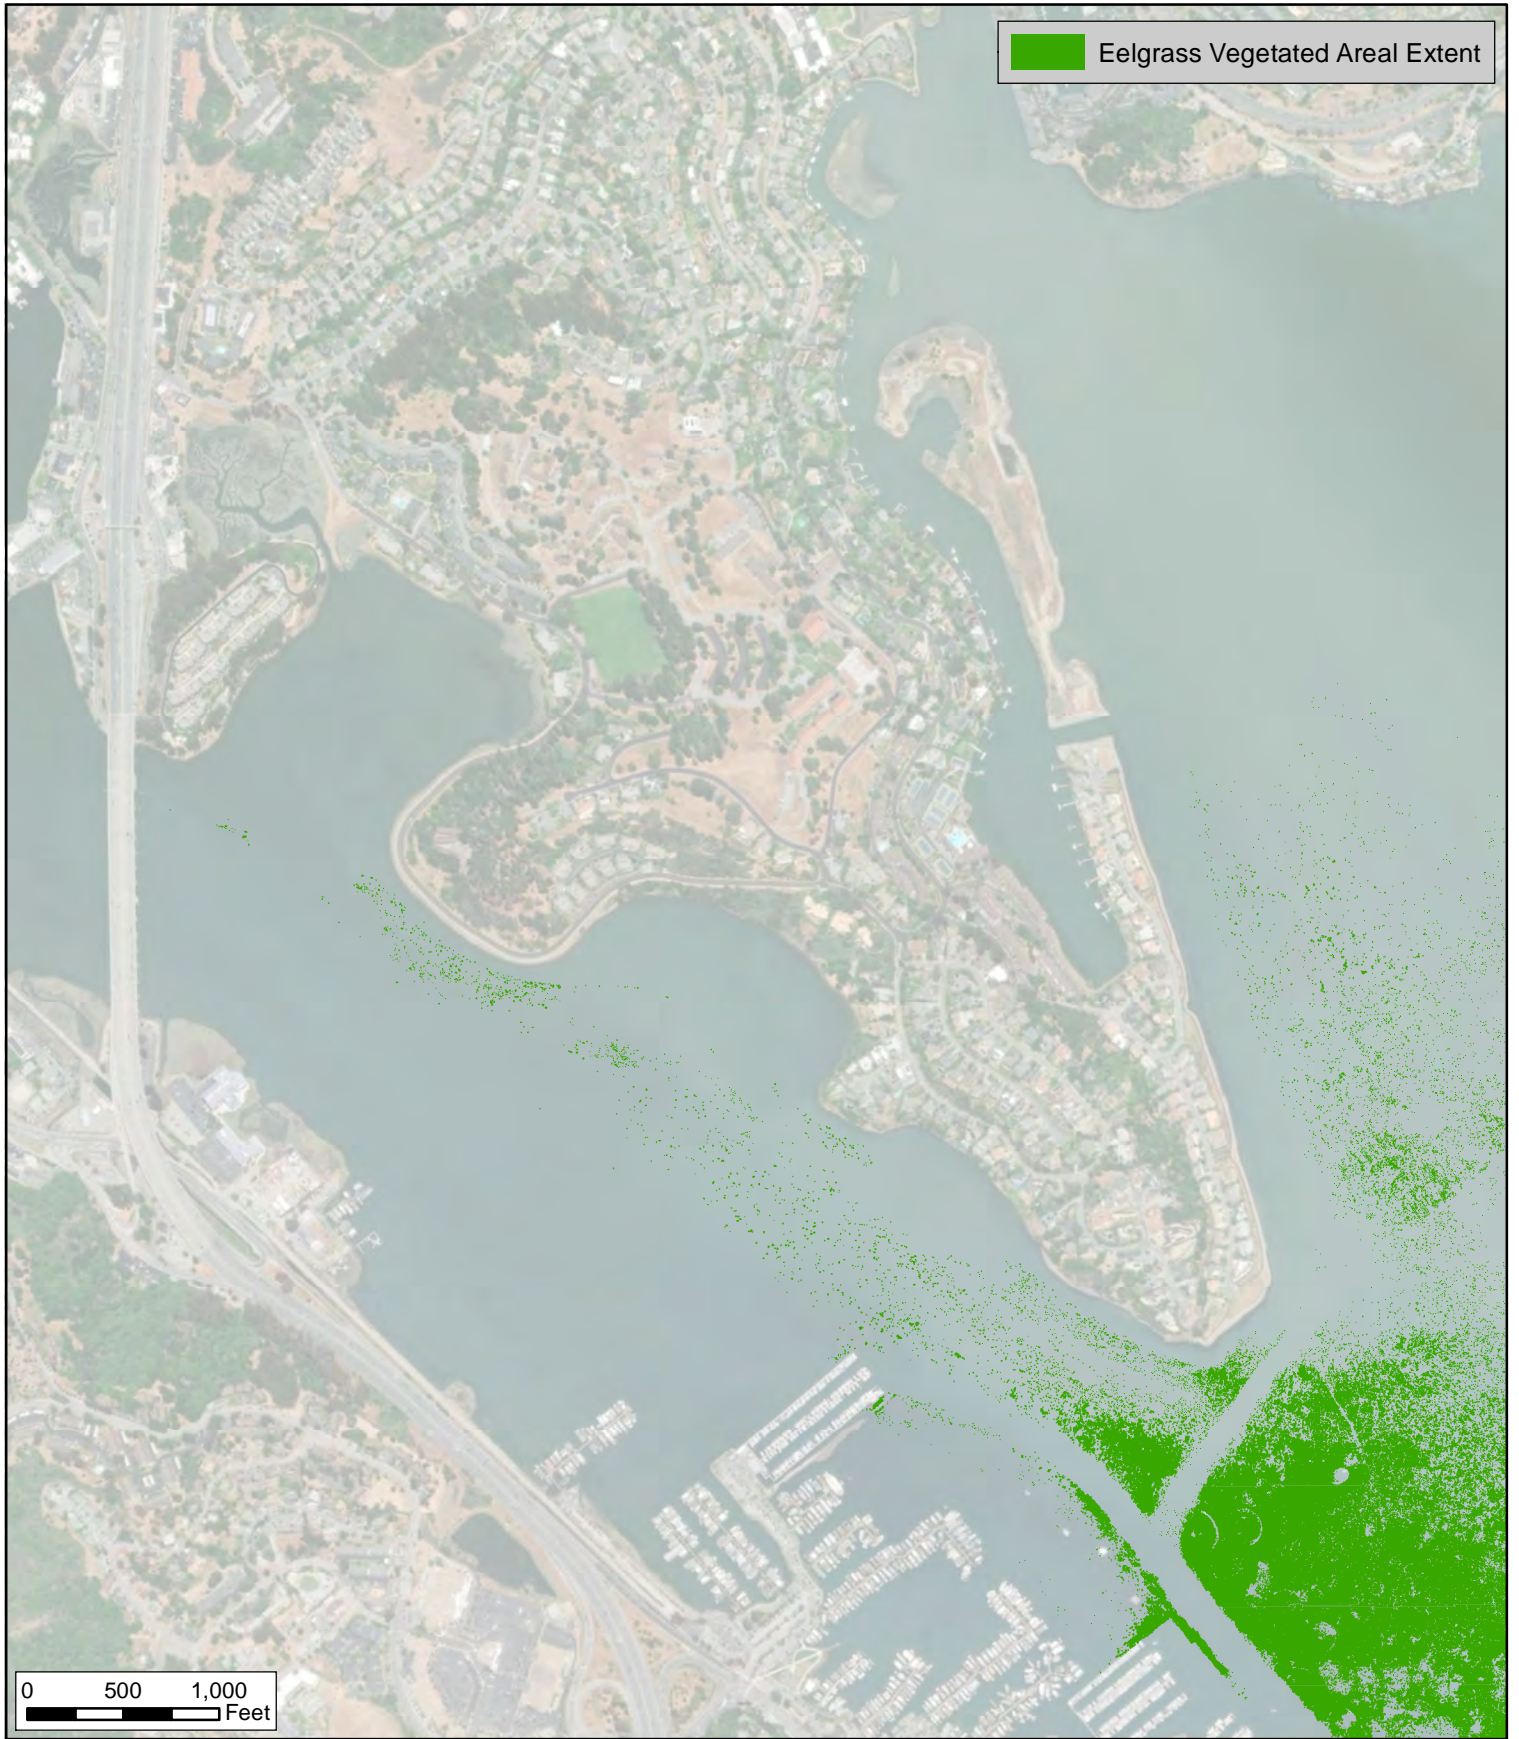
Figure 2a

Eelgrass Distribution - August 2022
2022 Richardson Bay Eelgrass Survey
Richardson Bay, CA

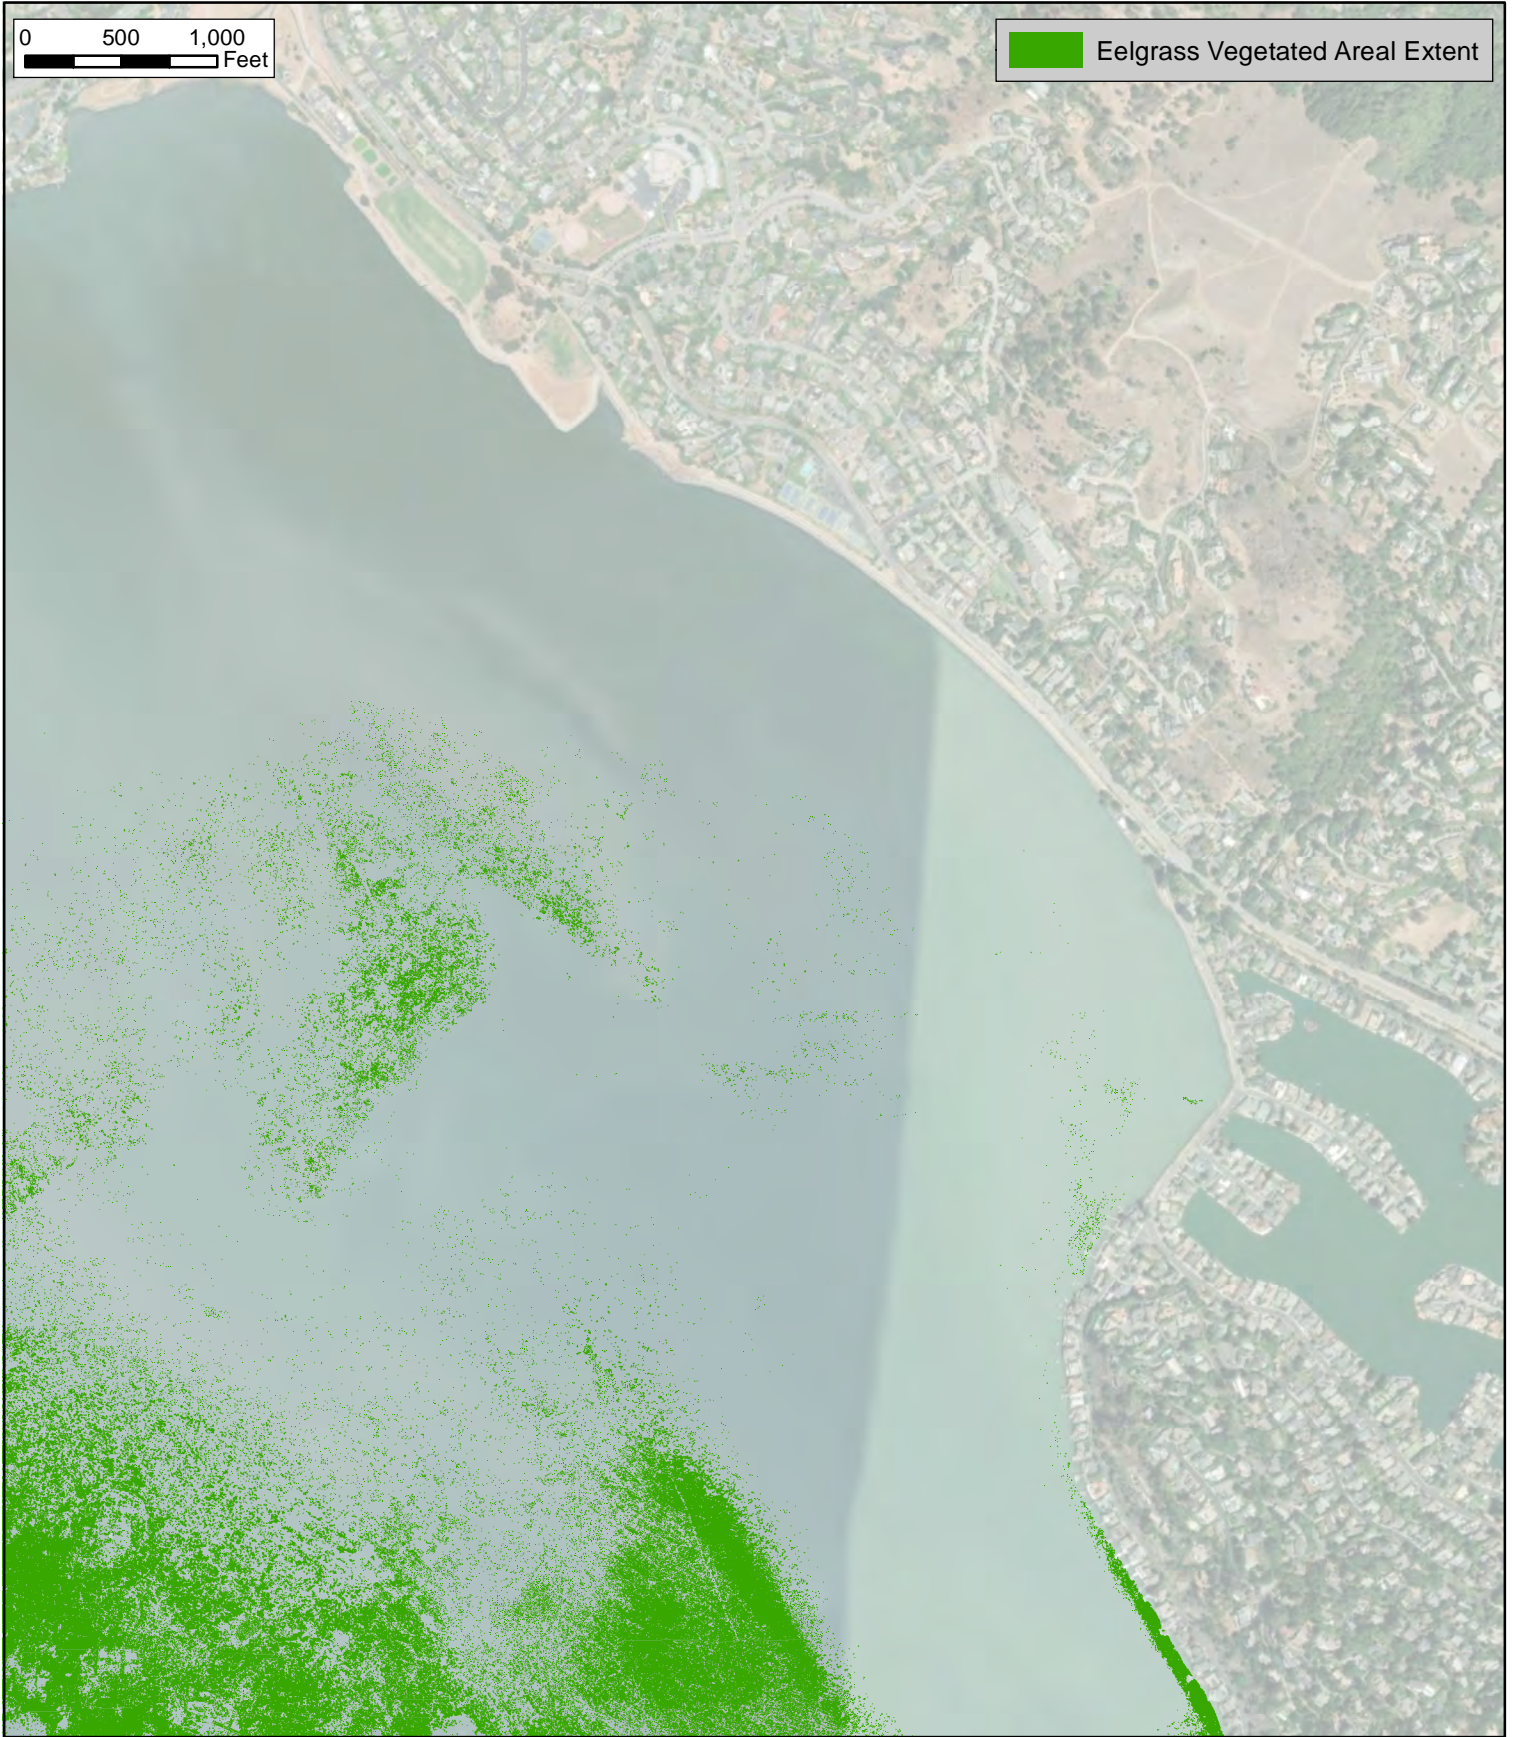
Figure 2b

Eelgrass Distribution - August 2022
2022 Richardson Bay Eelgrass Survey
Richardson Bay, CA

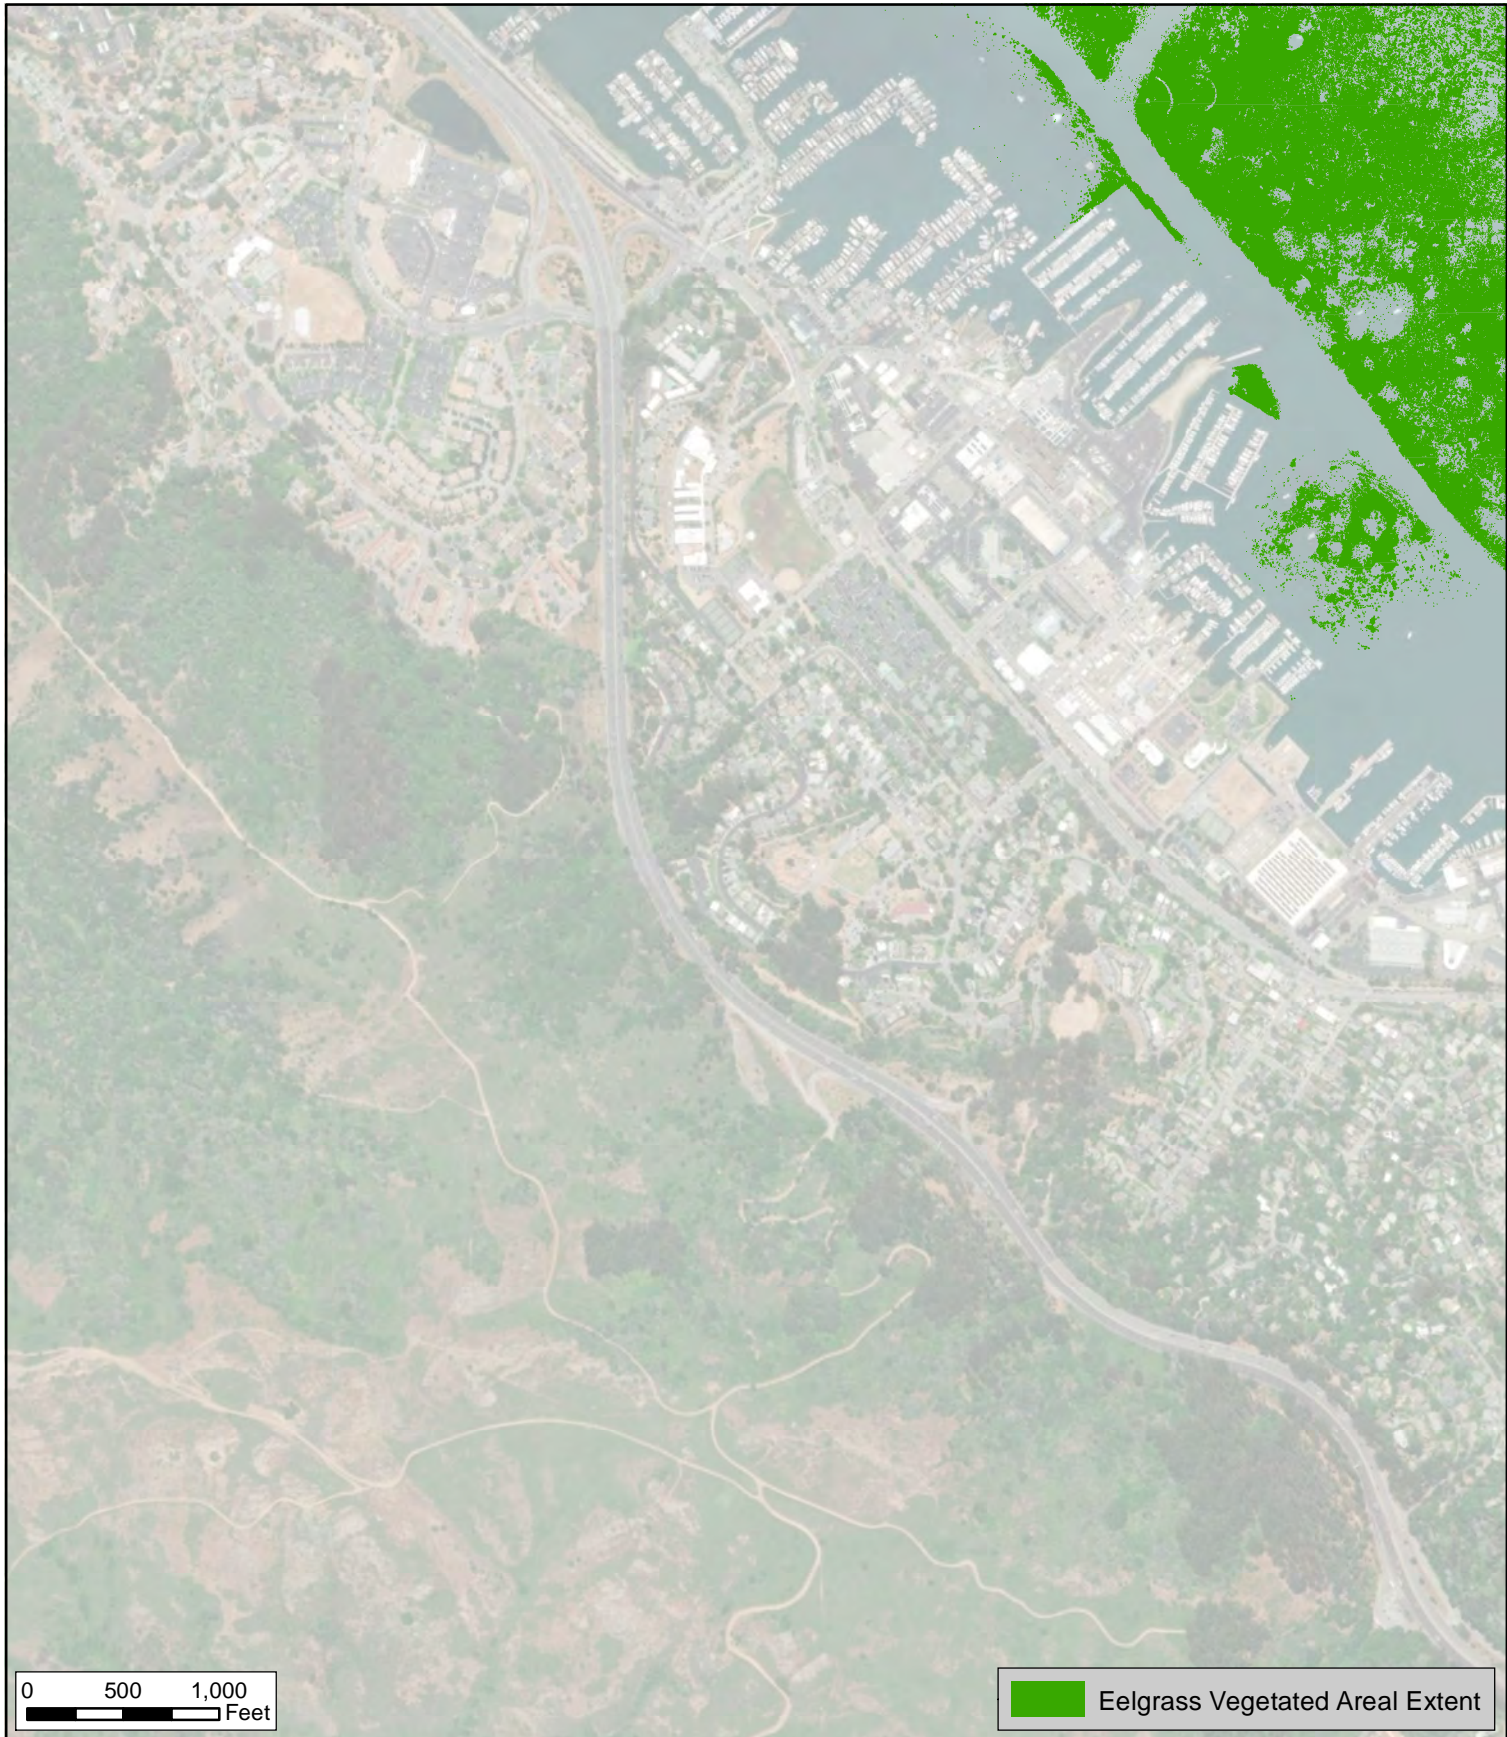
Figure 2c

Eelgrass Distribution - August 2022
2022 Richardson Bay Eelgrass Survey
Richardson Bay, CA

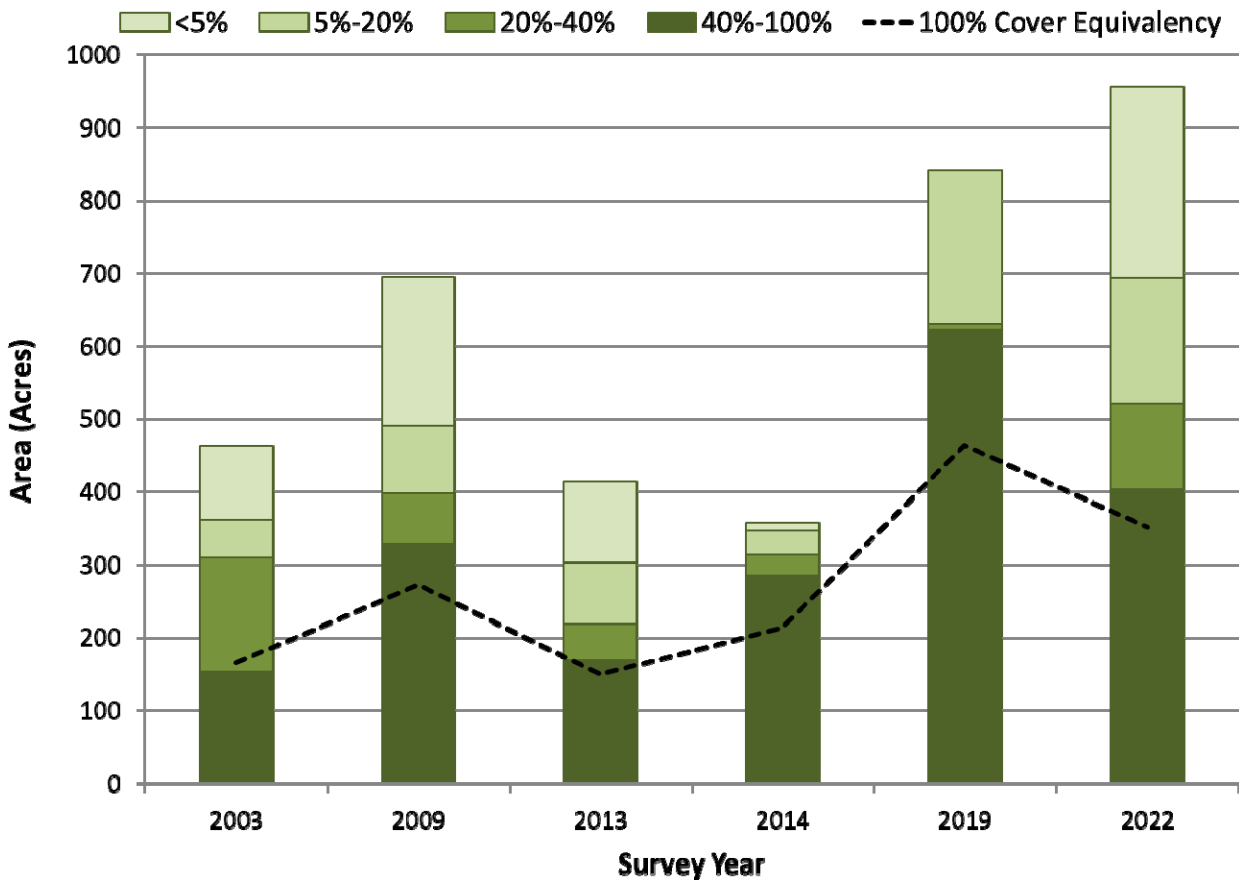
Figure 6. Changes in Richardson Bay Eelgrass Area Through Time

To evaluate the changes in eelgrass extent over time, it is useful to examine both the cumulative cover class area as well as the 100 percent equivalency area (Figure 7). This is the total area of eelgrass that would be present at a 100 percent bottom cover if the eelgrass were aggregated within a consolidated footprint. This value is beneficial when evaluating eelgrass bed productivity, biomass, or other metrics dependent upon plant density, such as carbon cycling and storage. The 100 percent equivalency is determined by multiplying the area of each cover class by the mean percent cover represented by the class and then summing across all classes. The results of the two analyses show that while the overall area of eelgrass expanded 13.6 percent between 2019 and 2022, the diminishing cover density observed in 2022 means that the 100 percent cover equivalency declined by 24.2 percent between the same years. While not reflected in the changes observed by July 2022, it is expected the continued declines of the core of the eelgrass beds observed by Audubon California in August 2022 and Merkel & Associates in October 2022, would further impair the eelgrass extent by late 2022.
