# RICHARDSON BAY EELGRASS RESTORATION AND ADAPTIVE MANAGEMENT PLAN

*MARIN COUNTY, CALIFORNIA*

*December 2023*

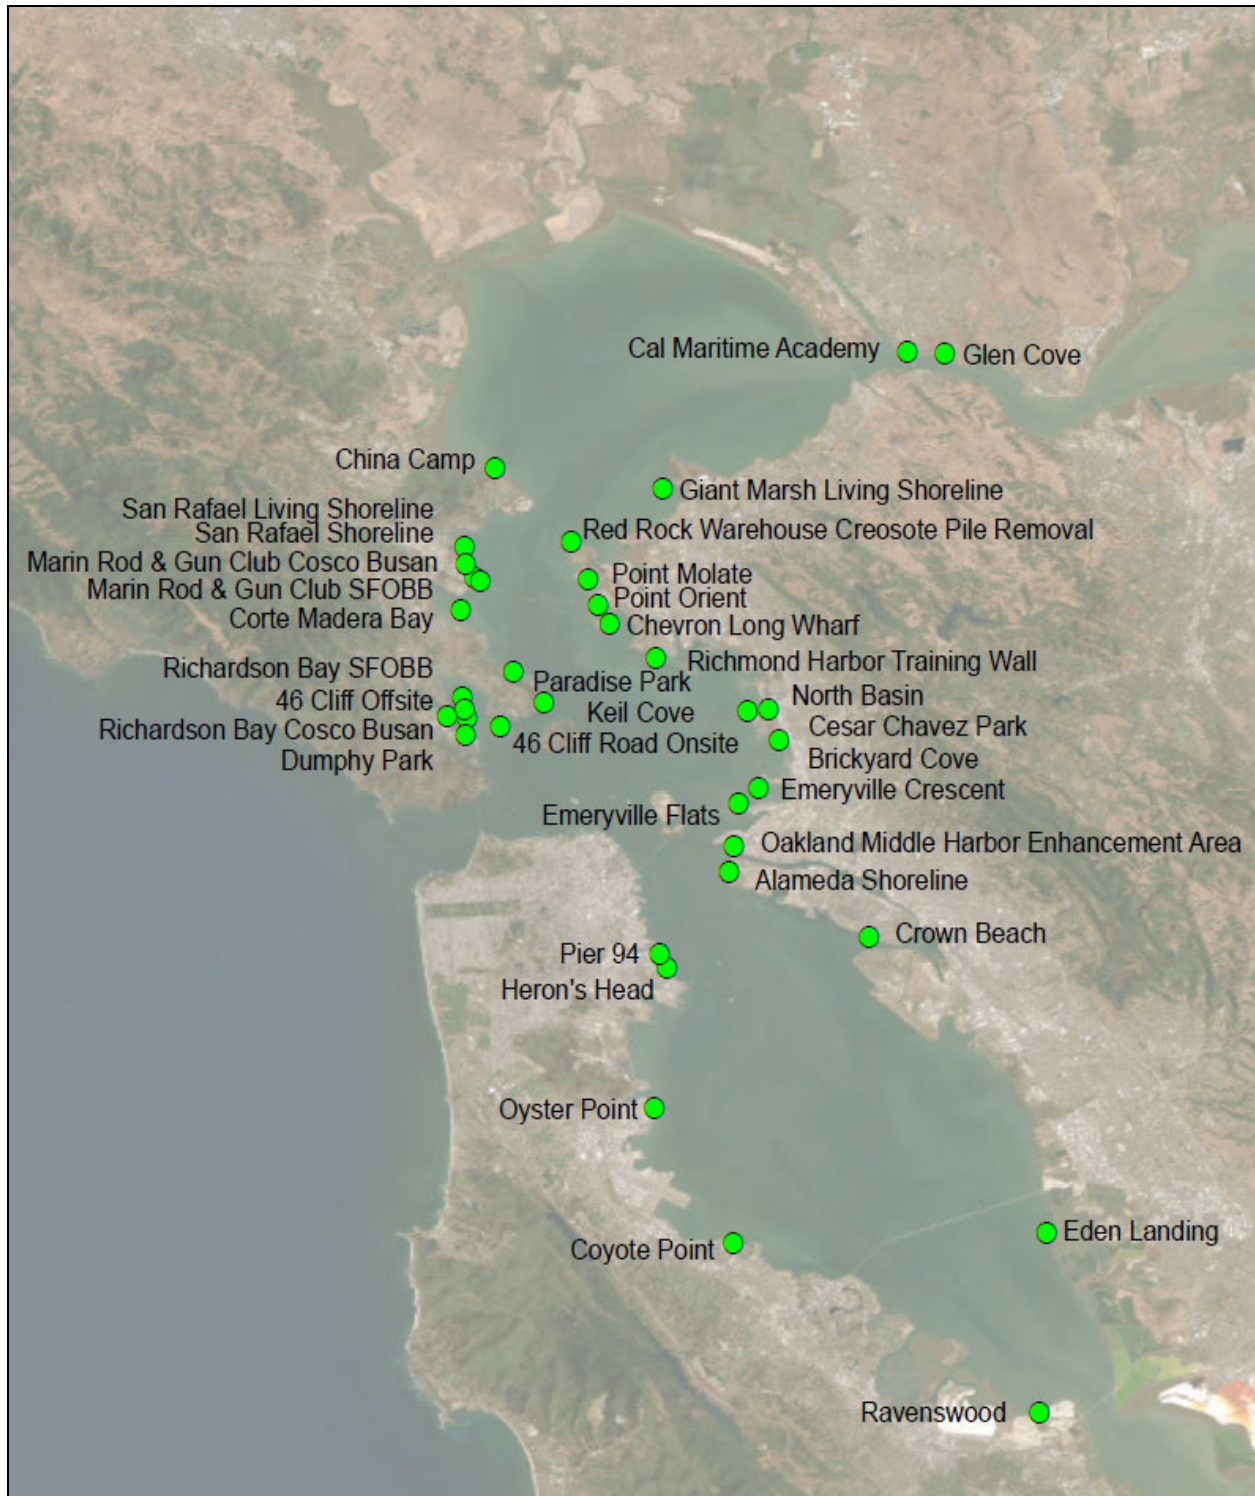
Figure 2. Eelgrass Restoration and Eelgrass Research Pilot Transplants (1985-Present)

This adaptive management approach has underpinned experimental and large-scale restoration efforts conducted in the bay since 1996 and the adaptive design has been critical to achieving successful restoration and managing resource investment in an efficient manner to achieve maximum eelgrass distribution and abundance through restoration.

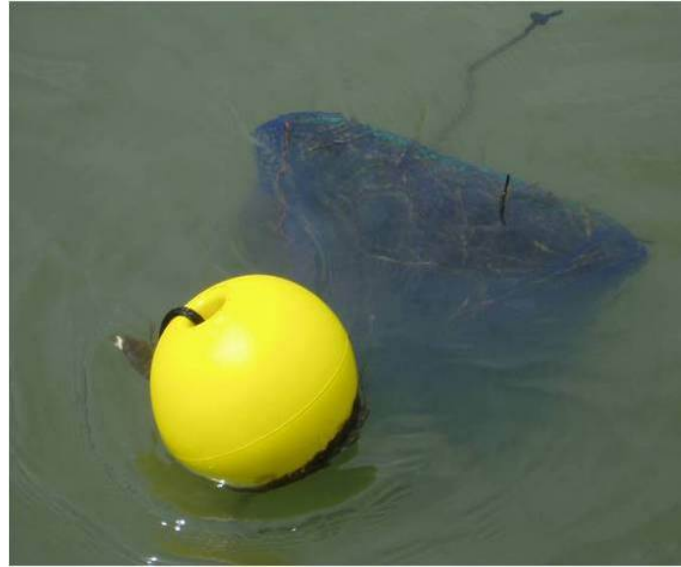
*Seed buoy eelgrass transplants at Marin Rod & Gun Club, San Francisco Bay*

Boyer has used seed buoy methods successfully and unsuccessfully at several sites in San Francisco Bay (Boyer et al. 2008) and the methods are ready to be “scaled-up” to larger restoration efforts. The seed buoy system was applied in 2014 transplants for the Cosco Busan DARP restoration and used a temporary anchor attached to a float that supported a 9mm mesh bag that held fertile flowering shoots harvested from donor populations. As the seeds within the flowering shoots matured, they were released and fell through the mesh to the bay floor beneath the bag.

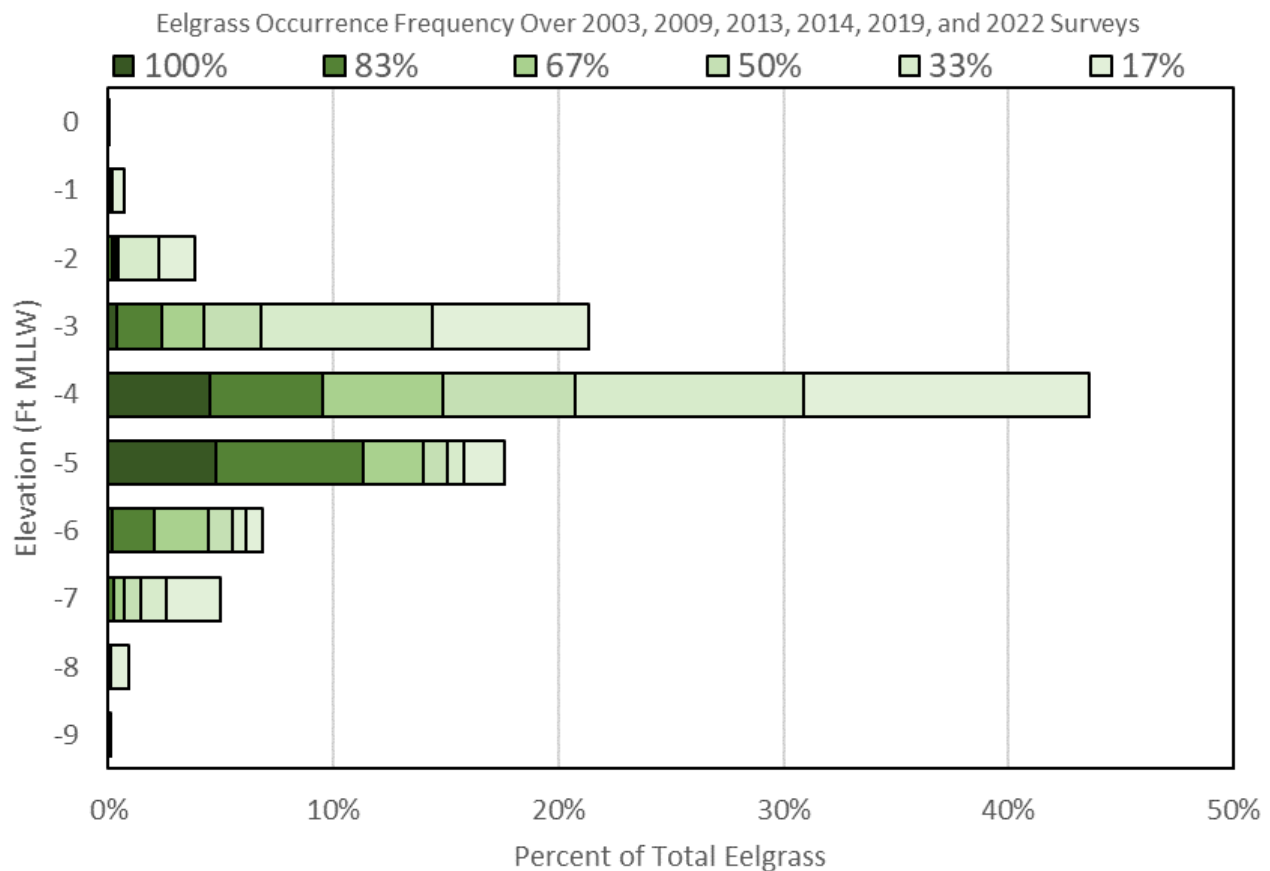
**Figure 7. Eelgrass Depth Distribution and Eelgrass Bed Stability**

Planting elevation is also a factor as it pertains to bed stability and planting team composition required (wading or diving staff). The most stable beds in Richardson Bay are reflected by those that have had the highest occurrence frequency over multiple surveys. When depth distribution of eelgrass in the bay is charted along with the frequency of eelgrass occurrence through time it is possible to identify the bay floor elevations that have had the most consistent presence of eelgrass through time. As such, these elevations should be preferentially targeted to obtain the most stable success. While early restoration should include some of the easy areas to achieve success, these should be balanced with work on more complicated restoration in dynamic portions of the beds such that adaptive restoration research and methods development can continue to advance. The overall restoration objective is to restore damaged areas across all elevations and geography of the beds. Omitting these areas would ultimately result in a failure to achieve the restoration objectives and would push the most difficult areas to restore to later periods of the restoration program when funding is less certain. As sea level rise progresses, higher elevations of the bay floor will become more important for retaining eelgrass resiliency in the bay (Gilkerson et al., in prep.).

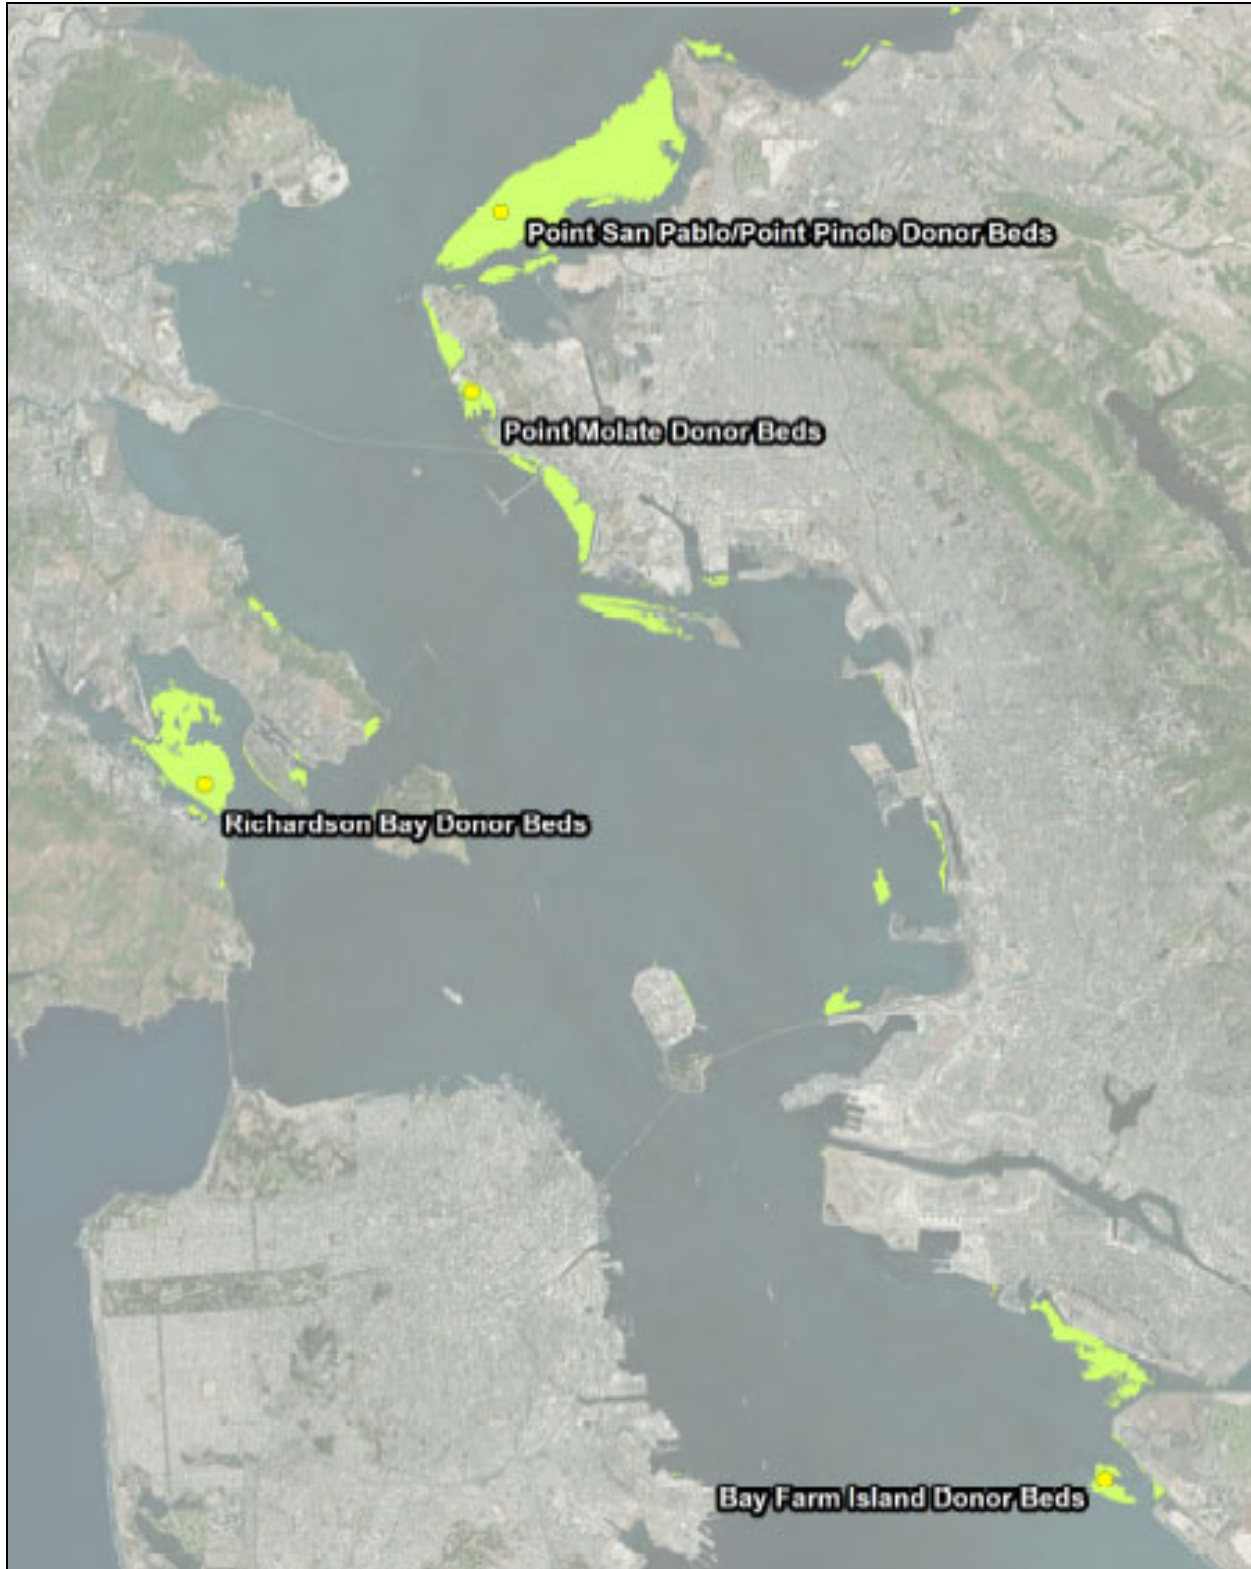
Figure 8. Eelgrass Donor Beds

Donor sites were selected for multiple reasons. First, the donor areas all supported relatively extensive, well studied beds that could provide adequate donor material to support on-going Cosco Busan restoration efforts in parallel with the present EPA funded restoration program. Second, the beds in these areas are large enough to support all years of the multiple eelgrass restoration efforts presently underway without taxing the donor sites. Third, these donor sites are broadly distributed across multiple physically stressful environments with respect to substrate, salinity, water clarity, and environmental energy. For this reason, if there is any adaptive advantage to the material under differing environments, a broad spectrum of environmental conditions are represented by the donor stock and would be expected to be reflected in progeny of these mixed donors. Finally, all of these beds have been investigated genetically and been found to be unique from each other (Ort et al. 2012; Talbot et al. 2004). This provides a high potential for maintaining and expanding genetic diversity within the restored beds, over the diversity of any single donor site.

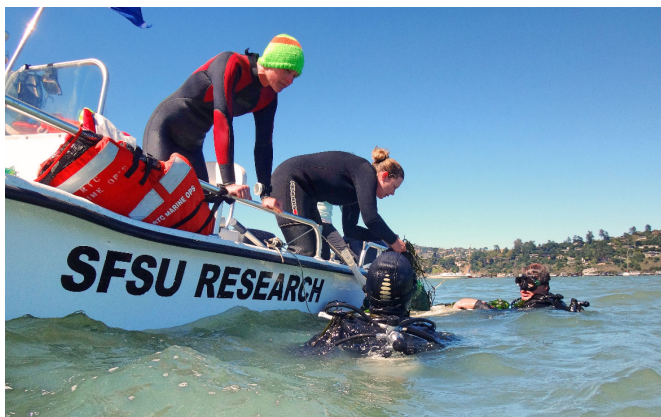
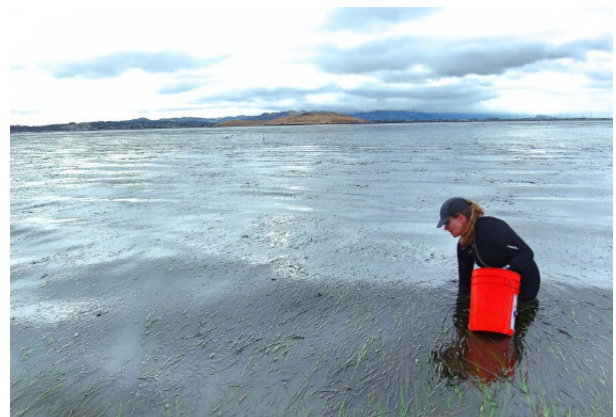
The harvest is performed either by SCUBA diving within subtidal beds, or intertidally by walking or crawling through the beds and collecting donor materials. This harvesting methodology progresses through the beds with hand extraction of shoots and intact rhizomes at a low-density harvest level. Using this harvest approach the visual results of harvesting are often undetectable following the harvesting. Further, because planting is typically targeted to occur early in the growing season and shoot density generally increase through the growing season, it is not uncommon for the post-harvest density assessments to show a greater density of shoots than did the pre-harvest survey.

*Harvesting of material from subtidal areas of Richardson Bay and intertidal areas at the Point San Pablo/Point Pinole donor sites by Merkel & Associates and SFSU project team members.*

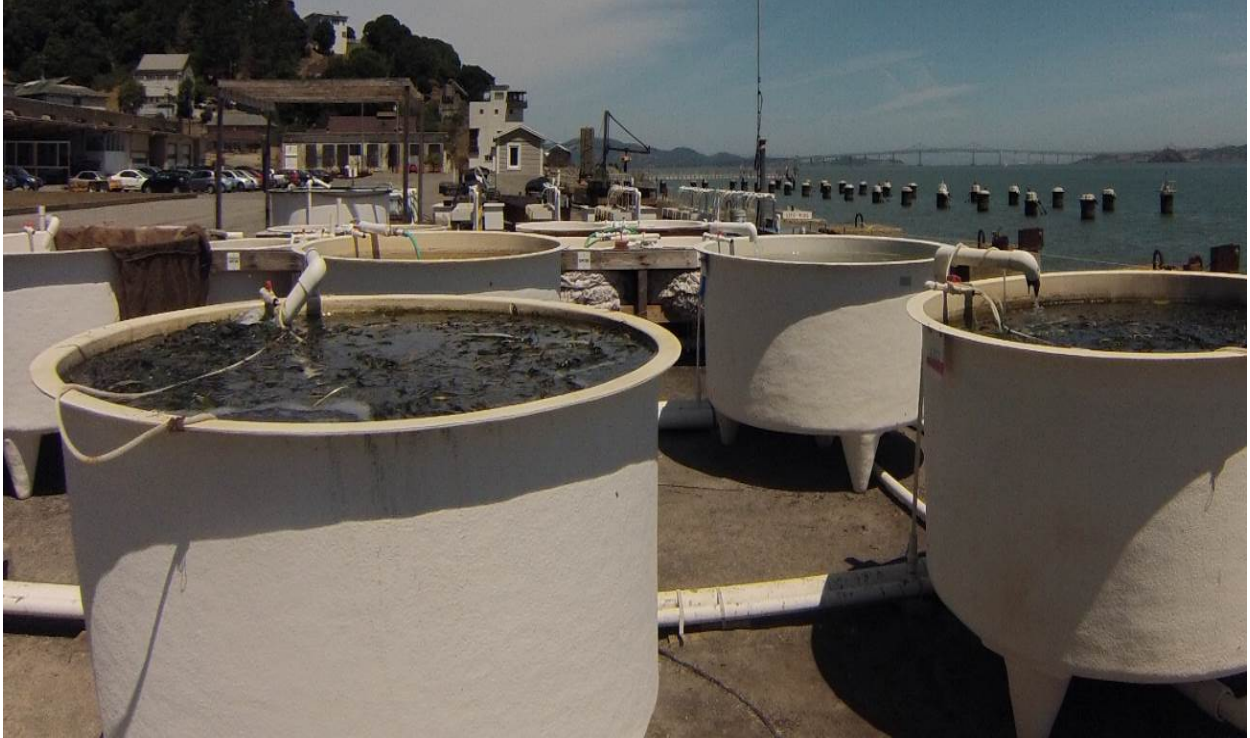
As plants are harvested, they are either laid in bins under wet burlap to avoid desiccation and thermal stress, or they are retained in mesh bags in the bay water until they are transported to the Estuary and Ocean Science Center within one to three hours of harvest where they are placed in flow-through large seawater tanks for storage prior to preparation of bareroot planting units. Tanks are set to circulate flow-through sea water and air stones are placed in each tank.

*Flow-through seawater tanks used to store eelgrass from donor sites until processed into planting units. Tanks were then used to store processed planting units until they were planted at the transplant receiver sites.*

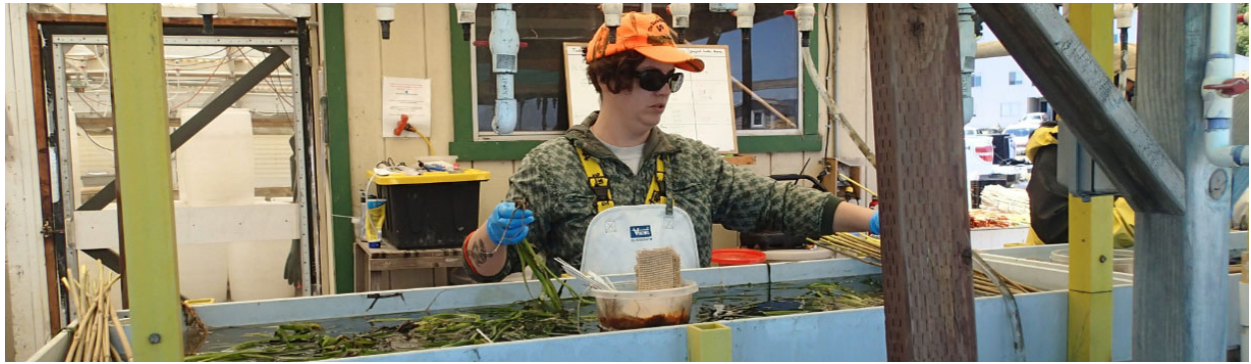
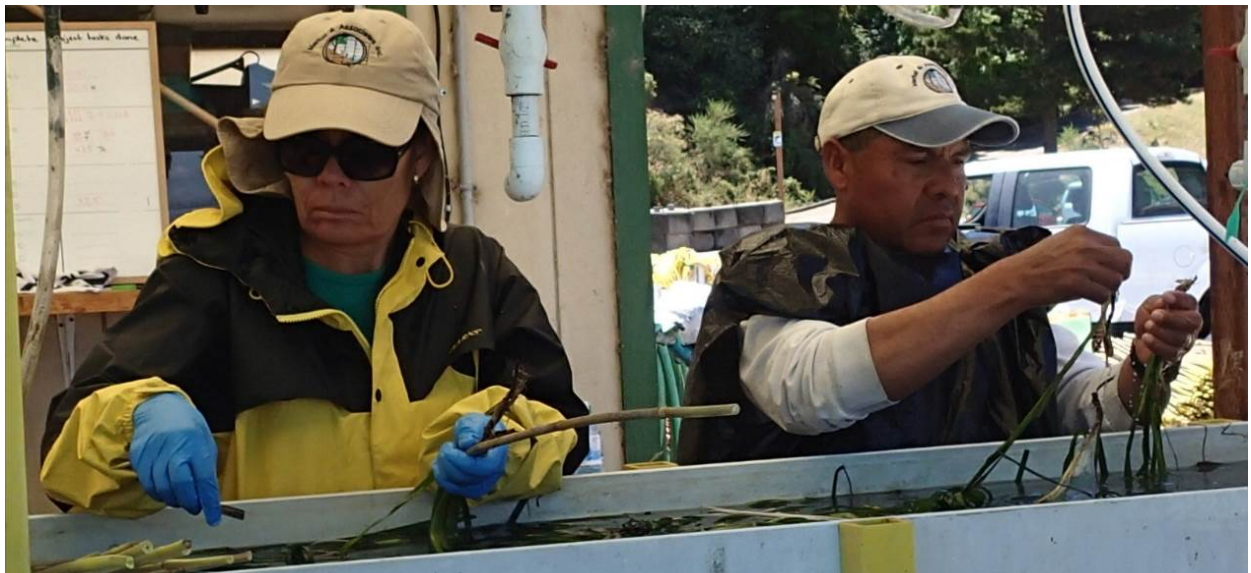
Planting units are generally prepared within 24 hours of harvest of the eelgrass and are then stored once more in the flow-through seawater tanks to keep them cool and oxygenated until they are planted, typically within 48 hours. Planting units are identified by color coding of either the bamboo stakes or the carrying fids used for paper stick anchor units. Each donor site had a consistent unique color that has been maintained through the San Francisco Bay Eelgrass Restoration Program since 2014. When planting units are placed back into the seawater baths prior to planting, they were grouped in a manner that supported planting of each discrete planting area based on the site size and intended donor plant materials to be used in the restoration. This allowed plants to be picked up and loaded onto boats for each planting day in a manner that minimized handling and potential for planting errors.

Water-tables used to process donor eelgrass into bare root units. The eelgrass units being prepared in the photograph are Kiriakopolos bamboo stake units.

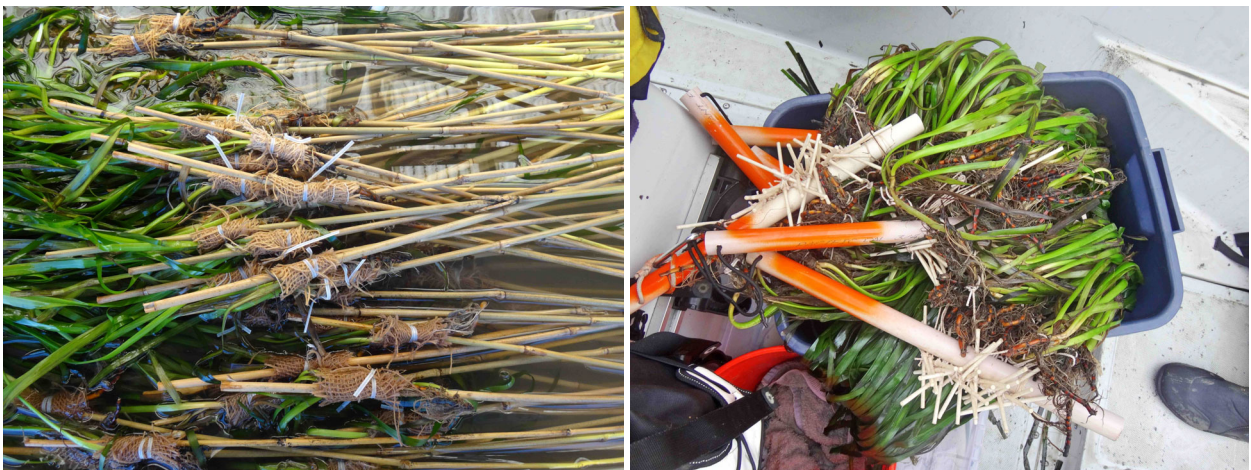
Prepared planting units of Kiriakopolos bamboo stakes and Merkel paper stick anchors ready for transplant. Color coding denotes the donor source material in the planting units.

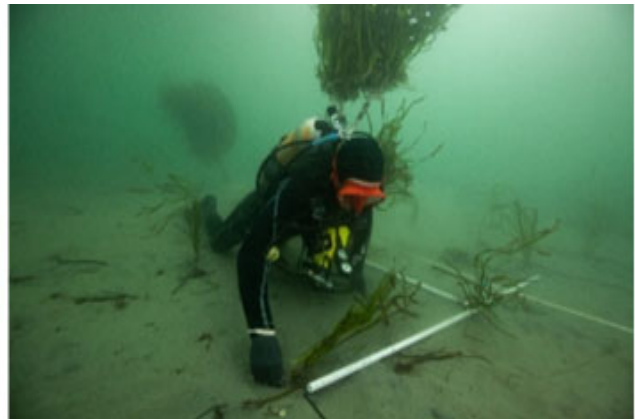
For planting, a planting “T” is used to control the spacing of planting units along the planting lines. This planting “T” has three 1-meter long legs. Plants are installed at the center point of the “T” and at the ends of each of the arms. The “T” is then advanced until the center leg end reaches the plant that was installed along the top of the “T”. The diver then advances to the new top of “T” and plants three more plants. The line is shifted over when the diver completes the planting of three rows. In the photograph it is possible to see the diver working along the line with a “T”. Above the diver are two fids loaded with bareroot paper stick anchor planting units. In the background are three sticks of eelgrass floating up from the line weight. These sticks will be planted on the next line move made by the diver.

*Example of eelgrass grid planting for illustrative purposes. Clarity in San Francisco Bay does not occur to this level.*

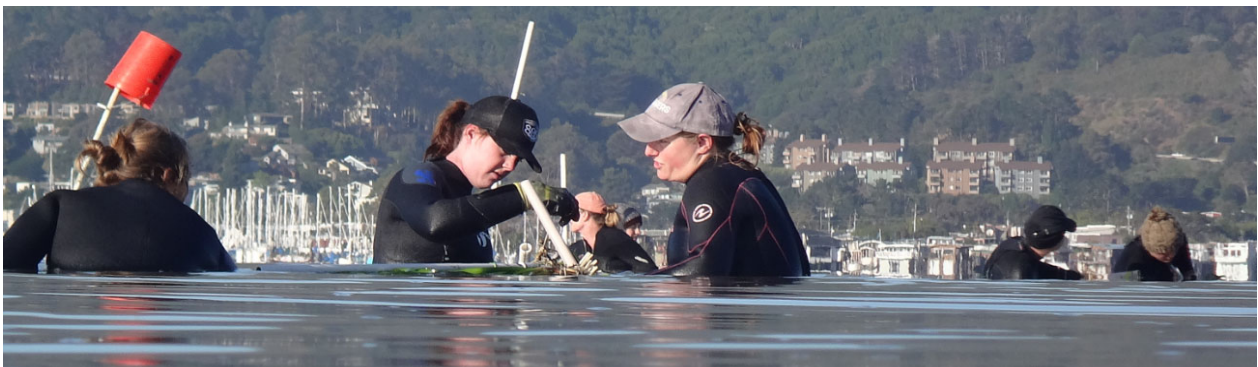
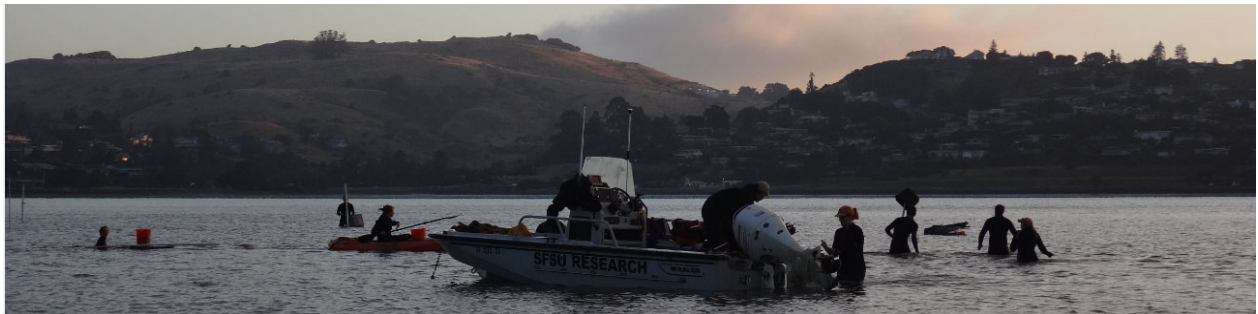
The photographs on the following page depict planting conducted by the Merkel and Boyer eelgrass team for the San Francisco Bay Eelgrass Restoration Program using funding derived from Cosco Busan DARP and SFOBB eelgrass restoration programs.

*Eelgrass planting at Corte Madera Bay, Marin Rod & Gun Club, and Richardson Bay Audubon Sanctuary. Planting varied from subtidal planting by divers to intertidal planting by wading. Temporary guidelines and corner stakes were set prior to planting and removed following the planting efforts.*

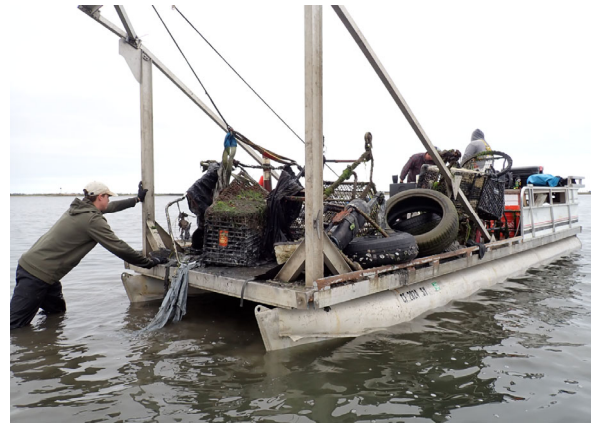
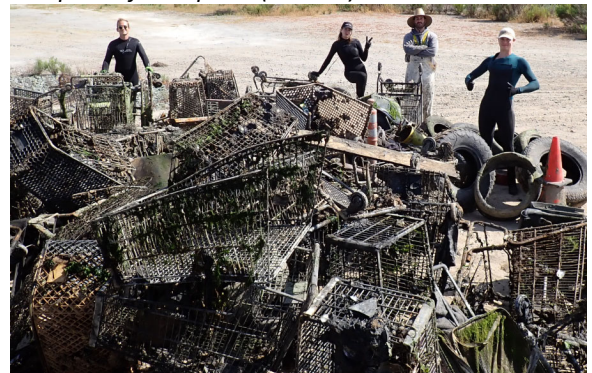
Divers working in teams will load large baskets with debris from the bottom and the pontoon boat will crane lift these to the deck for disposal. The boat will carry a spill response kit, including petroleum absorbent pads and booms as sometimes removal of debris such as fuel tanks, motors, and spray cans can release contents. A containment pool for leaky objects will also be present on the boat decks.

Example from San Diego Bay of debris collected by divers and waders that is loaded into baskets or direct rigged to be winch lifted onto a deck boat (top). This material is then be amassed for loading into dumpsters for disposal (bottom).

Once debris is loaded on the pontoon boat, it will be transported to the Army Corps ramp as Sausalito where the boat will be unloaded and debris will be placed into dumpsters for disposal. This material will be disposed of within the RBRA waste stream for vessel marine debris.

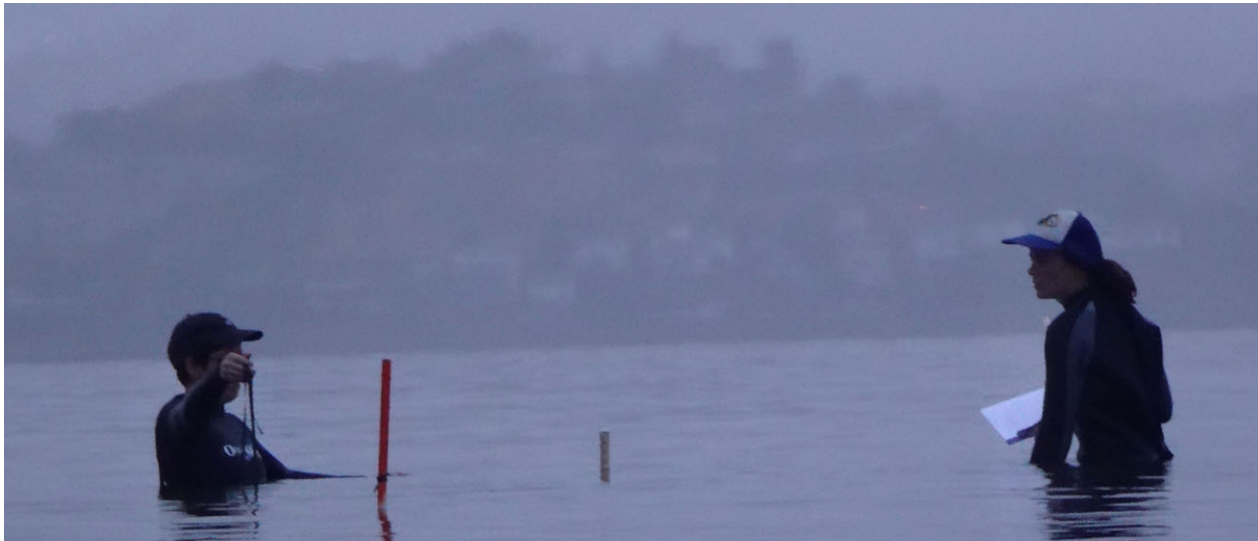
Direct observations of plants will be undertaken once a season during the fall in order to collect data on plant conditions. Transplant and reference site reviews will include an assessment of: 1) the presence or absence of eelgrass within the planting plot; 2) the mean density  $\pm$  1 standard deviation of shoots present within the surviving plants; 3) measurement of plant heights; 4) reproductive status of plants. In addition, plants will be assessed for overall vigor as well as any identifiable biotic or abiotic stressors including signs of disease, evidence of herbivory, percent epiphytic loading, color, and leaf turgor. These qualitative and quantitative metrics provide insights into site conditions and potential stressors on the native and transplanted eelgrass.

*Early morning low tide monitoring conducted in Richardson Bay. Plant survival, growth, and height are being assessed.*
